Manhole Inspection Summary

Manhole # S17II1001MH

Location Address: **2319 DERBY RD**

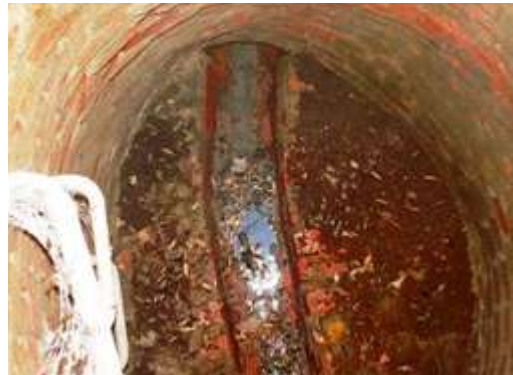
Top View

Bench and Channel debris.

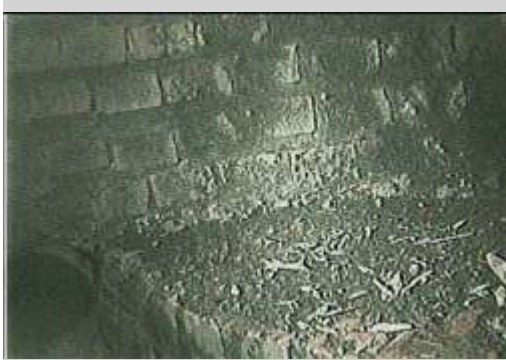
Defect

Barrel infiltration. Bench debris.

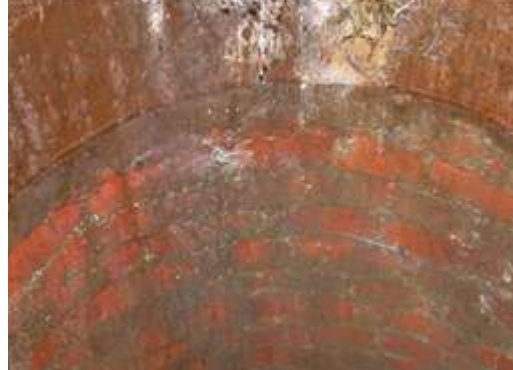
Defect

Frame leaks. Adjustment deterioration and infiltration.

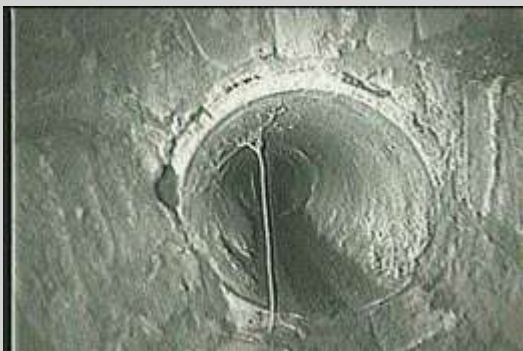
8 in. Circular Gravity Sewer Pipe In @ 5 O'Clock

Infiltration: **Evidence** Pipe Seal Cond: **Unknown**
